ウィルミントン大学平和資料センター保管品

**Damaged Roof Tile from Hiroshima (Left)**  
**Undamaged Roof Tile from Hiroshima (Right)**  
*Traditional Japanese Clay Kawara Roof Tiles*

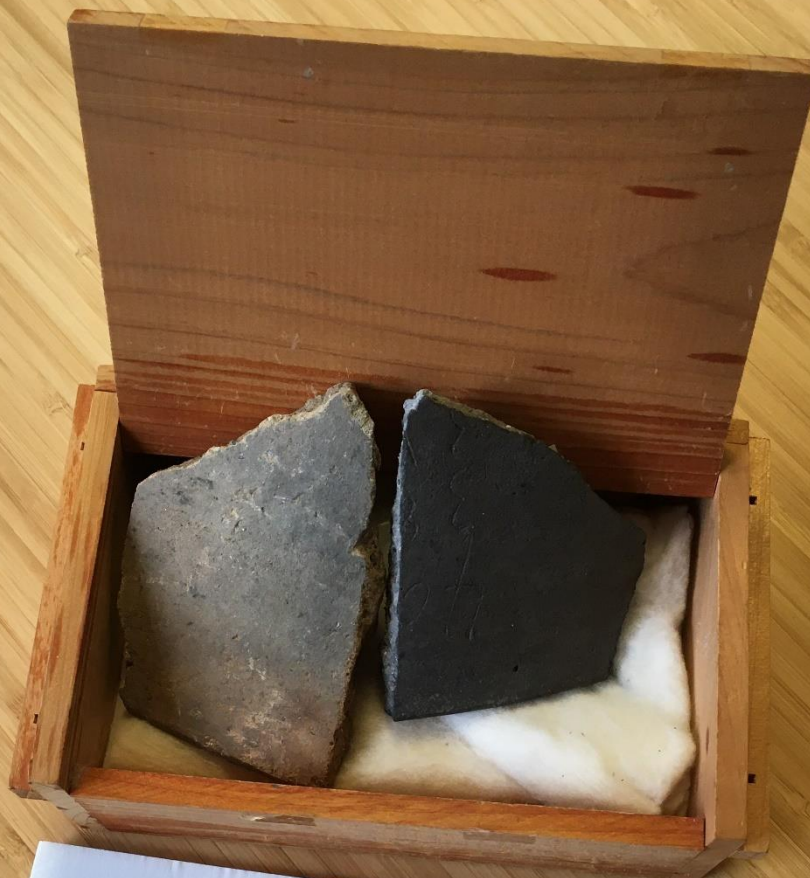
The tile on the left was burned, charred, and destroyed in the bombing of Hiroshima; it was approximately 1/3 mile from Ground Zero. At detonation, the estimated heat from the atomic blast was between 7,000°-9,000° F. The heat that damaged this tile reached about 1800° F, and it would have taken approximately 3 seconds for this damage to occur. The tile on the right is the same roof tile but undamaged.
